# PROBLEM SOLVER<sup>®</sup>

## BULLETIN

## LEAKING/WORN STRUTS

ALL VEHICLES

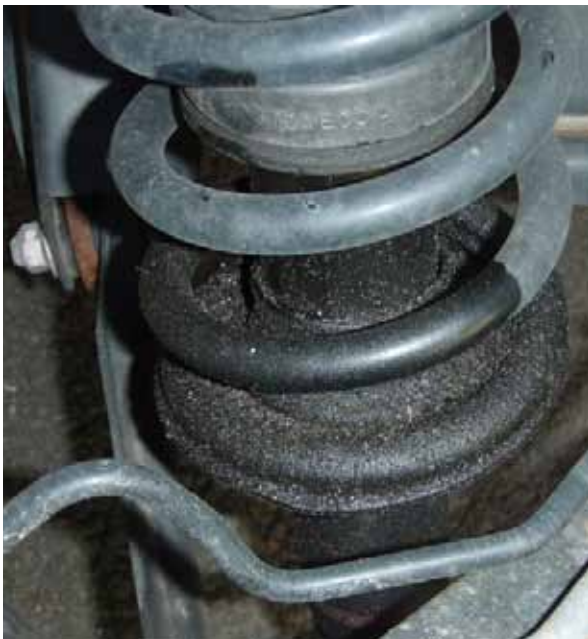
Debris can enter the seal cavity and lead to premature wear of both the main seal and the piston rod. This causes the strut to leak hydraulic fluid. Fluid loss will lead to further problems, including product failure.

Pressure spikes are a rapid rise in the static pressure of the strut's hydraulic fluid. These spikes are caused by shock loads – from rough roads or a single forceful road impact, such as hitting a pothole. Pressure spikes can force fluid past the main seal, resulting in fluid leakage. Pressure spikes can also permanently damage the main seal, which will eventually lead to product failure.

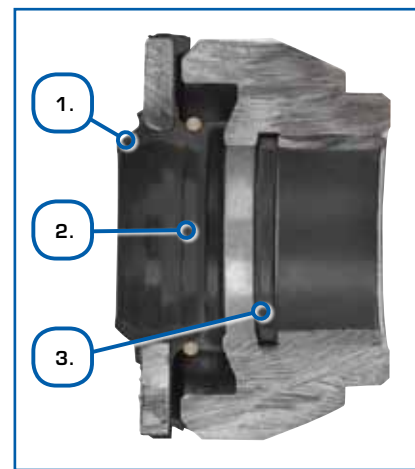
**(1) Outer wiper seal** cleans the piston rod, preventing contaminants from entering the strut and damaging the main seal. **(2) The MOOG main seal** is a one-piece molded design featuring twin seal lips, optimizing sealing performance and durability. **(3) An exclusive inner PTFE buffer seal** absorbs high-pressure fluid spikes caused by rough road impact, improving the efficiency of the main seal, for longer seal life.

The problem-solving MOOG<sup>®</sup> Triple Piston Seal offers dual protection to an enhanced main seal, resulting in longer life.
