# PROBLEM SOLVER<sup>®</sup>

## BULLETIN

# LOWER MOUNTING HARDWARE

#### Rusted Or Stripped Lower Strut Mounting Bolts

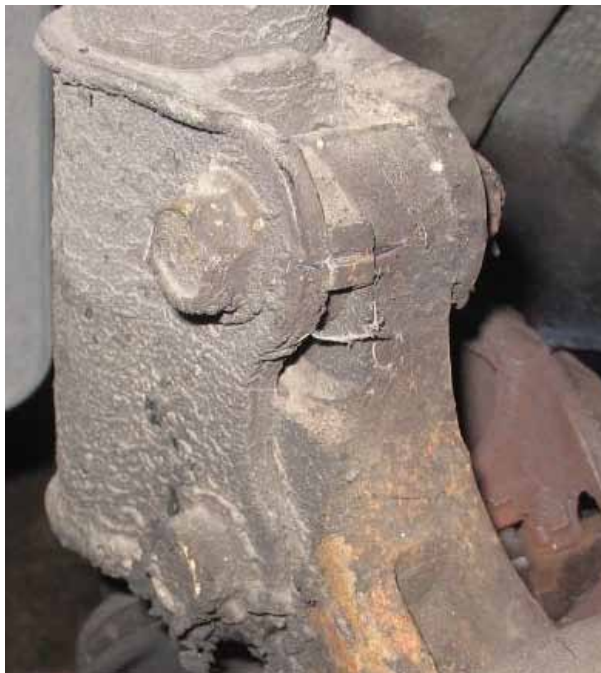
Vehicle age and/or environmental conditions can cause the lower strut mounting bolts to be rusted and difficult to remove. During the removal process, the bolts heads may become stripped; the nut or bolt heads may become rounded. If this occurs, they will need to be replaced. This may slow down the repair job, as sourcing new hardware may be time-consuming.

Many MOOG<sup>®</sup> complete strut assemblies include lower mounting hardware such as strut mount bolts or pinch bolts. This supplied hardware meets or exceeds OE specification, and combined with the MOOG complete strut assembly, provides ease of installation and a thorough repair.
